Manhole Inspection Summary

Manhole # S35AA_026MH

Insp Date: **1/28/08 11:21 AM**

Location Address: **17 BRANCH LANE**

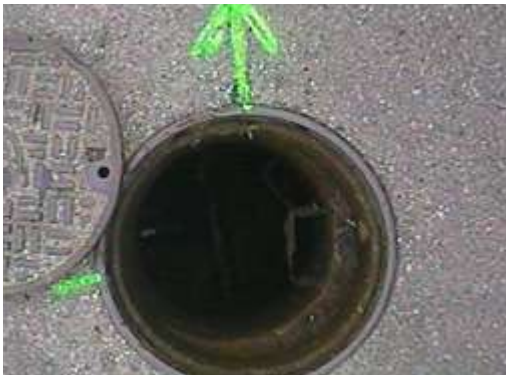
Defect 1

Frame Offset: **2** (in.) Condition: ☒ Sound ☐ Cracked ☐ Leaks

Steps Count: **6** Missing: **0** ☒ **Corroded**

CORRODED STEPS AND FRAME
OFFSET

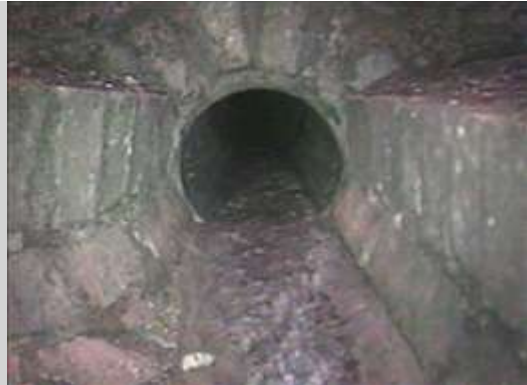
12 O'Clock Outflow

8 in. Circular Gravity Sewer
Pipe Out @ 12 O'Clock

Invert Depth: **9.90** (ft.) Flow Characteristics: **Slow**

Infiltration: **None** Pipe Seal Cond: **Sound**

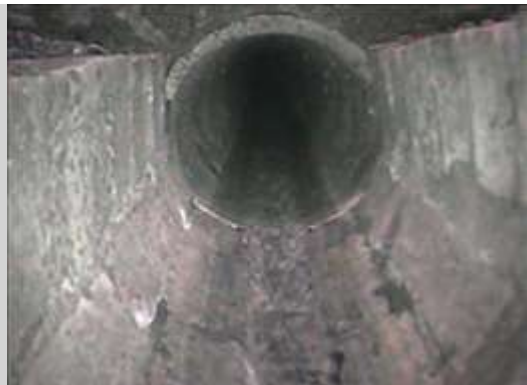
6 O'Clock Inflow

8 in. Circular Gravity Sewer
Pipe In @ 6 O'Clock

Invert Depth: **9.80** (ft.) Flow Characteristics: **Slow**

Infiltration: **None** Pipe Seal Cond: **Sound**

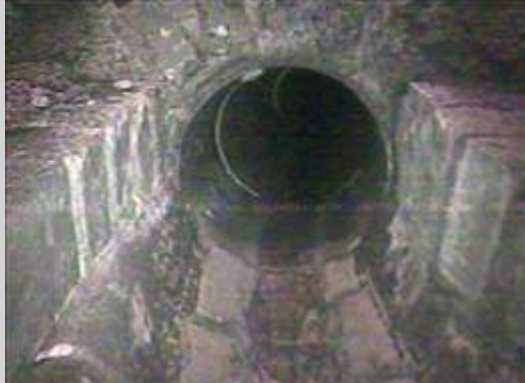
9 O'Clock Inflow

8 in. Circular Gravity Sewer

Pipe In @ 9 O'Clock

Invert Depth: **9.55** (ft.) Flow Characteristics: **Slow**

Infiltration: **None** Pipe Seal Cond: **Sound**
